The Coode Island Fires 20 years on - Ian F Thomas

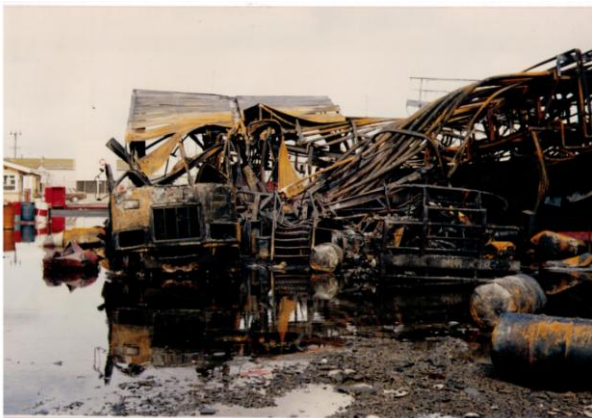
Truck loading area after the event

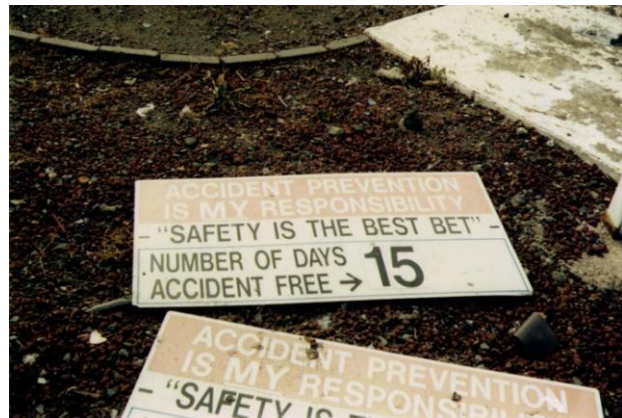
Sign found on ground after the accident

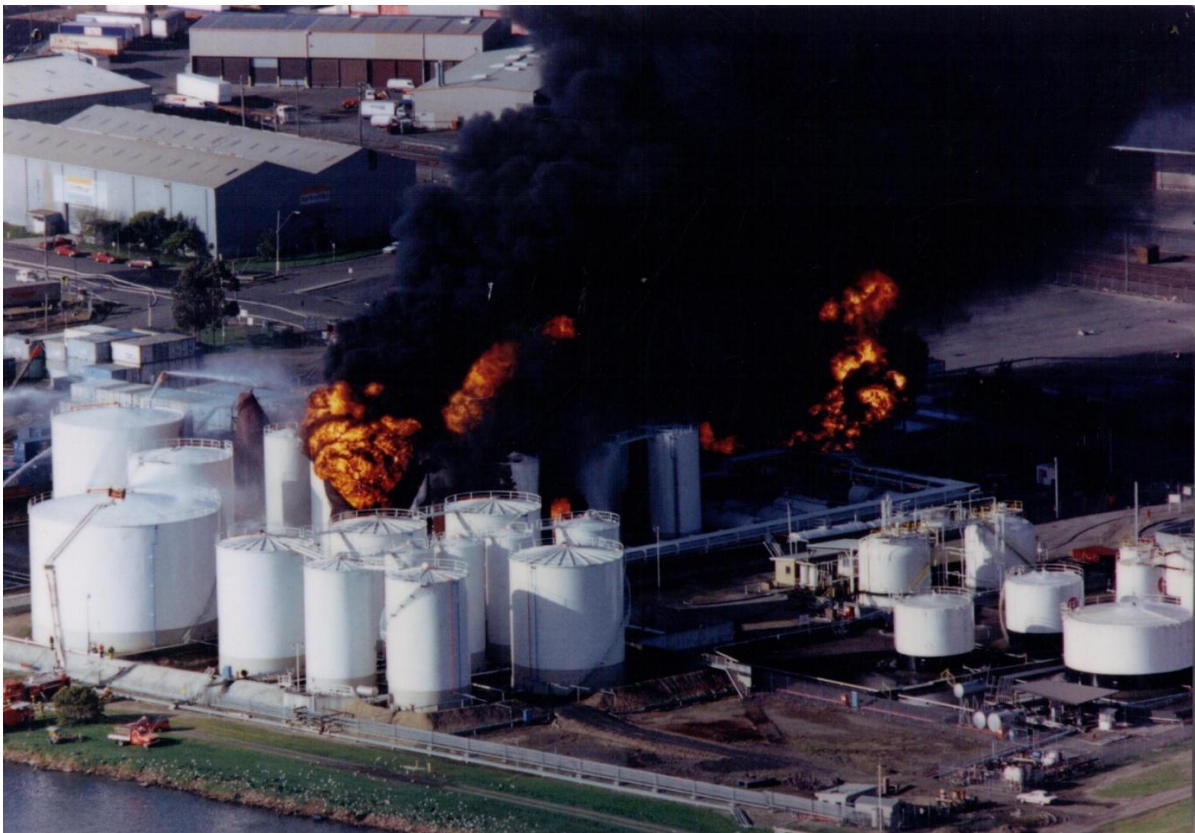
Aerial view courtesy of The Age newspaper
